## Thousand Island Park Historic Resource Survey and National Register Update Inventory Form

Building Name: \_\_\_\_\_ Lot No.: 1681

911 Address: 16967 Prospect Avenue

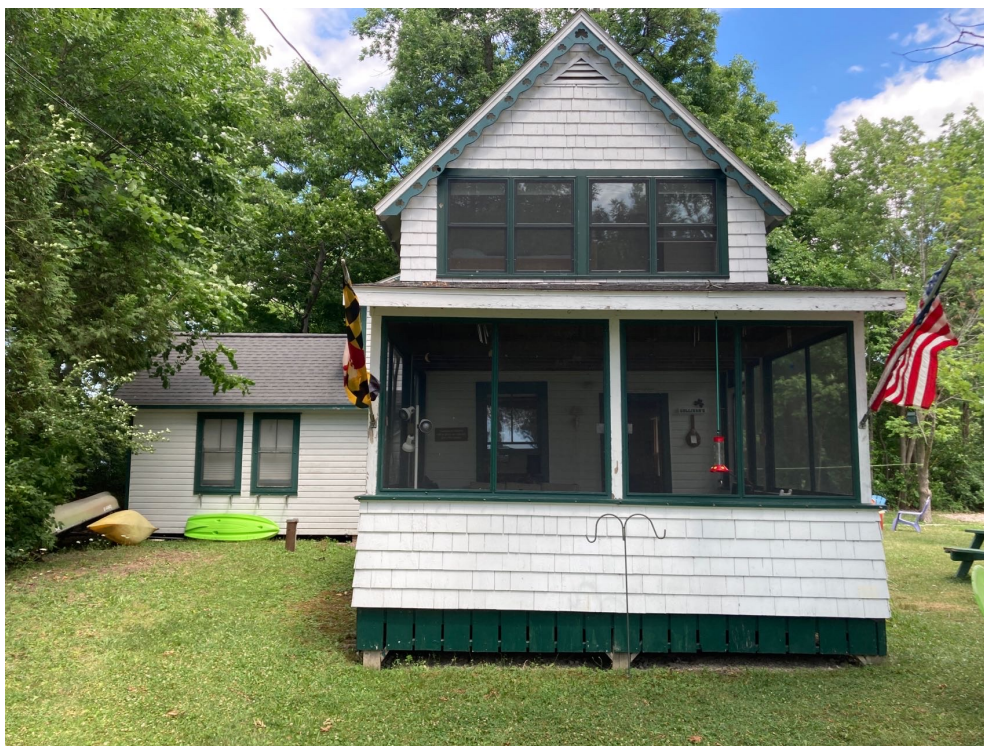
Photo:

Vergeboard trim added 1988

Rear addition after 1999

2nd floor front windows replaced after 1980 (compatible)

Seam, change in siding suggests an originally open porch enclosed prior to 1980. An update note added to the 1980 survey indicates that the porch was extended "as original" in 1986 - presumably this was when the front porch was extended farther forward than its 1980 configuration and the front door relocated to the side of the porch.
